# Home Inspection Report

1785 Little Willeo Rd, Marietta, GA 30068

Tuesday, July 18, 2017

CA Home Inspections of Georgia, LLC

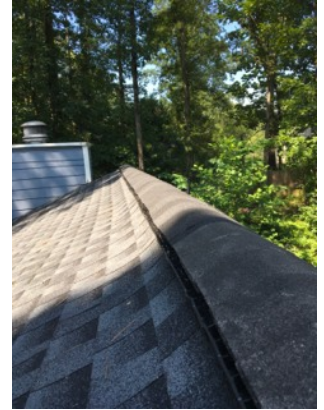
Bow in roof due to construction

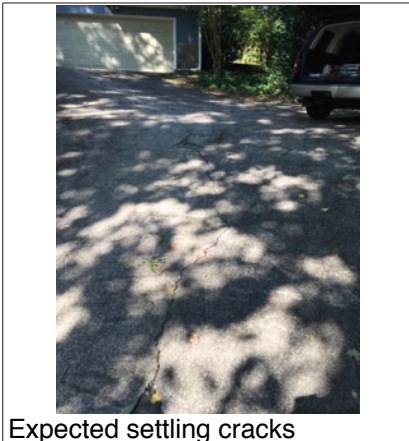
**Comments** •Driveway had some settlement, but usable. Recommend repair by qualified contractor as needed

Expected settling cracks

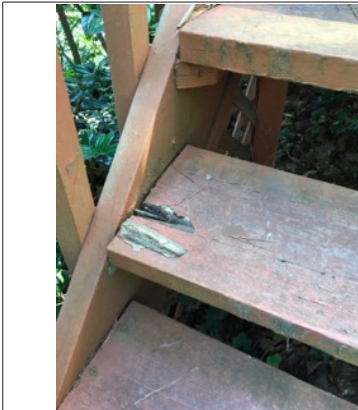
**Comments** •Front steps/porch wood shows signs of excessive wear and deterioration. Recommend painting/treating and/or repairing the wood on steps/porch.  
•Balusters too far apart, for additional safety recommend balusters be a maximum of 4" apart- SAFETY CONCERN for small children.

Deteriorated Front Steps

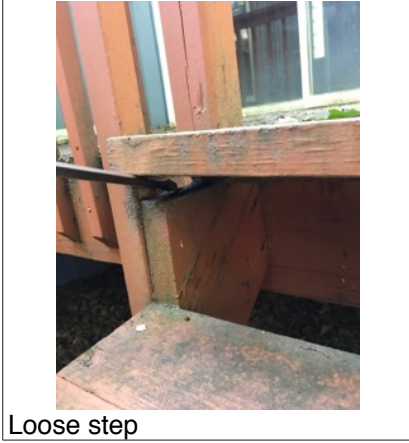
**Comments** •Loose steps on rear deck. Potential Safety Concern. Recommend repair by qualified contractor.  
•Rear deck wood shows signs of excessive wear and deterioration. Recommend evaluation, painting/treating and/or repairing by qualified contractor as needed.

Loose step

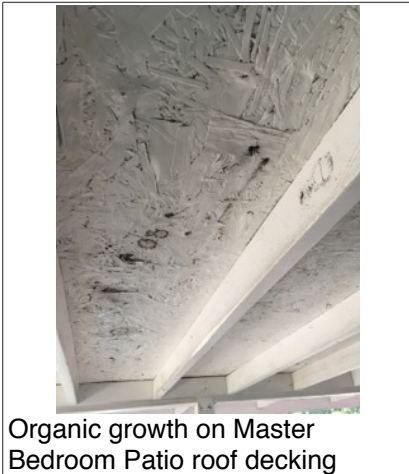
**Comments** •Master bedroom patio roof decking shows signs of organic growth and deteriorating wood. Monitor and have evaluated and/or repaired by qualified contractor as needed.

Organic growth on Master Bedroom Patio roof decking

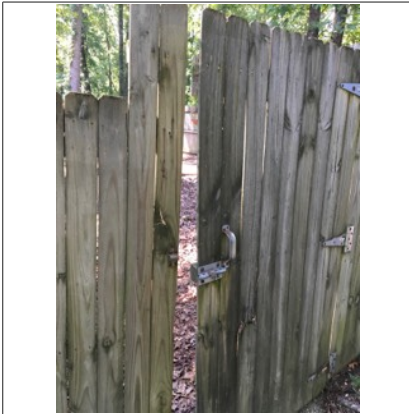
**Comments** •Fencing was in need of extensive repair and/or replacement.  
•Both fence gates would not close. Recommend repair by qualified contractor.

Fence gate not closing

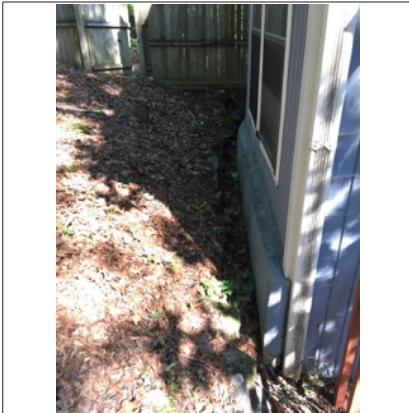
- Recommend trimming and/or removal of vegetation away from home.
- Recommend improving the grade immediately adjacent to the perimeter of the homes foundation to improve drainage. The grade should slope away from the foundation approximately 1" per foot for the first 5'-6' to discourage moisture penetration into the foundation.

Ground negatively sloping towards house

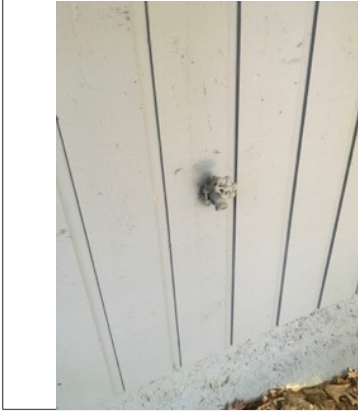
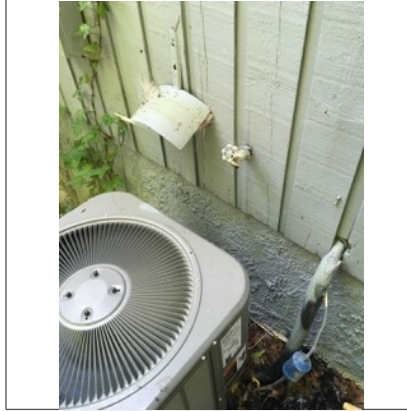
- Comments**
- Hose bib(s) leaking/dripping. Recommend licensed plumber repair.
  - Hose bib(s) not equipped with anti-siphon devices, possible cross connection can occur with anti-siphon device. Recommend installing.
  - Hose bib on left side of house was not operating at time of inspection. Recommend evaluation and/or repair by licensed plumber.

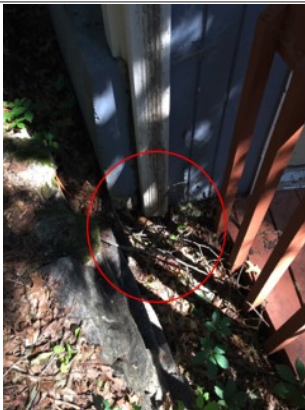
- Gutters had some damage and had missing sections. Recommend repairing/replacing damaged/missing sections.
- Insides of gutters are full of debris. Recommend cleaning.
- Recommend maintaining downspout discharge a minimum of 5-6' away from the house.

Missing downspout discharge

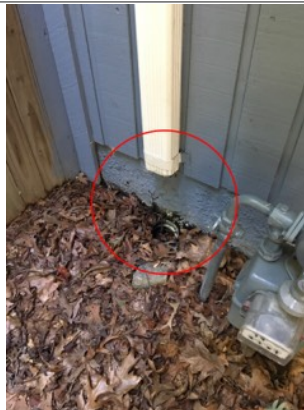
Missing gutter extension

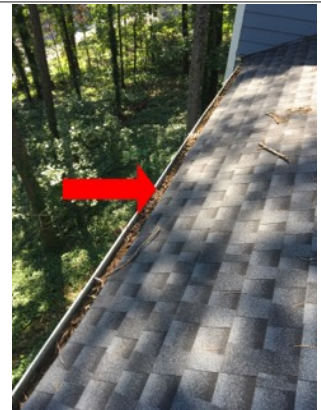
Gutter needs cleaning

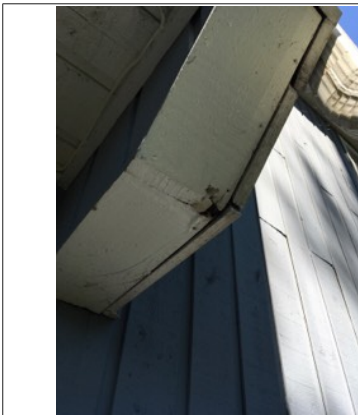
- Siding had some damage and deteriorated wood, recommend evaluation and repairing/replacing damaged sections by qualified contractor.
- Access panel on front of house not properly installed. Recommend repair by qualified contractor.
- Siding in contact with soil recommend keeping a clearance of 6-8" from bottom of siding to soil.

Deteriorating wood siding

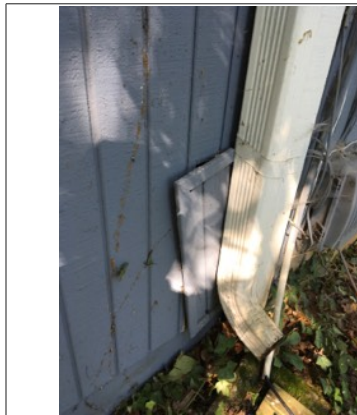
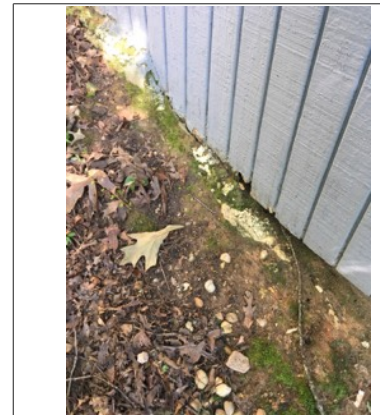
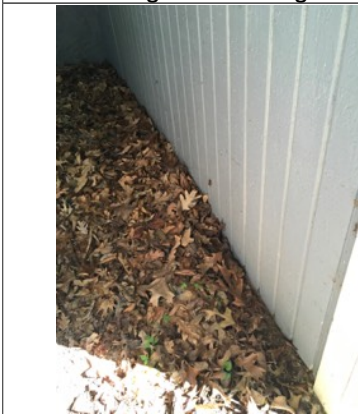
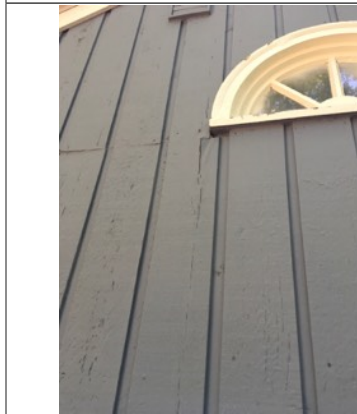
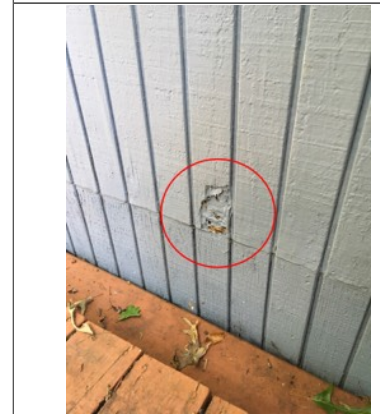
Deteriorating wood

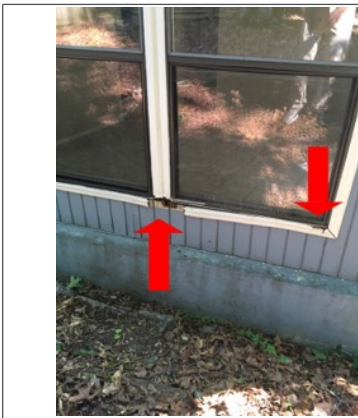
•Multiple window door trims throughout the home showed signs of deterioration. Potential for insect and/or moisture penetration. Recommend evaluation and/or repair of damaged trim by a qualified contractor.

Deteriorated trim and siding

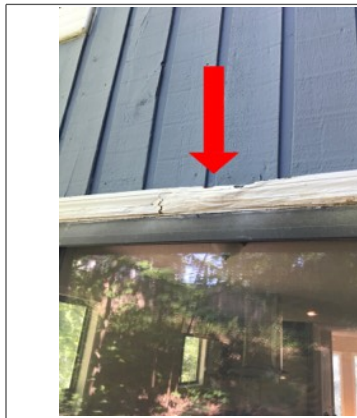
Deteriorated trim

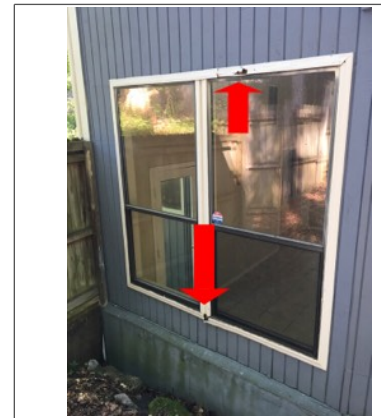
Deteriorated trim

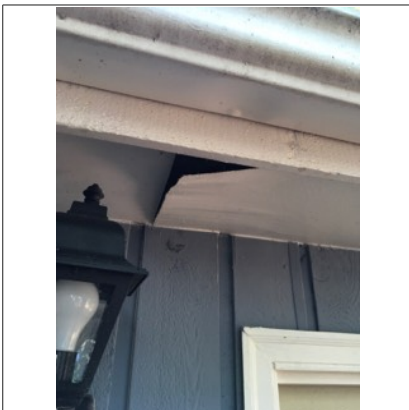
•Soffit vents covered/painted over not functional, recommend repair and/or replacement.  
•Soffit is sagging, damaged, and showing signs of deterioration. Recommend evaluation and/or repair to maintain ventilation and insulation by qualified contractor.

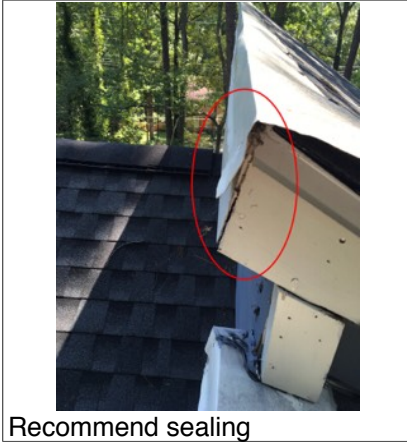
- Fascia is loose/rotted/damaged. Recommend evaluation and/or repair by qualified contractor.
- Recommend caulking/sealing fascia to prevent moisture penetration.

Recommend sealing

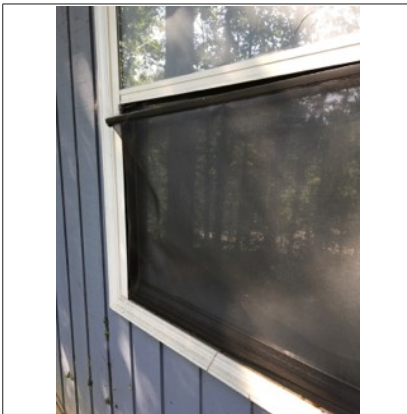
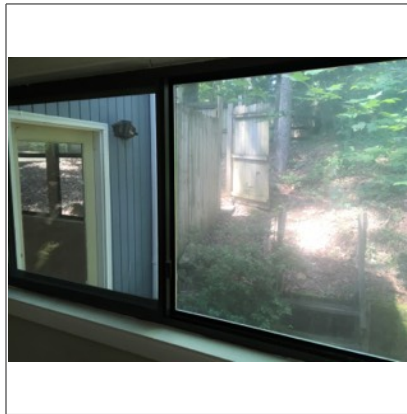
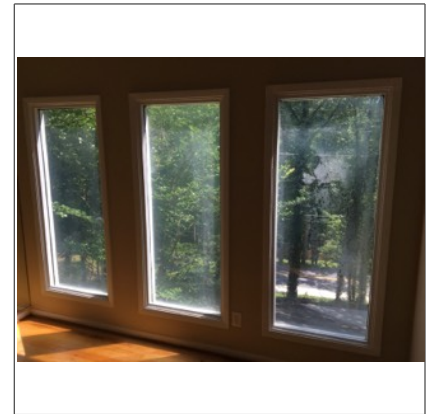
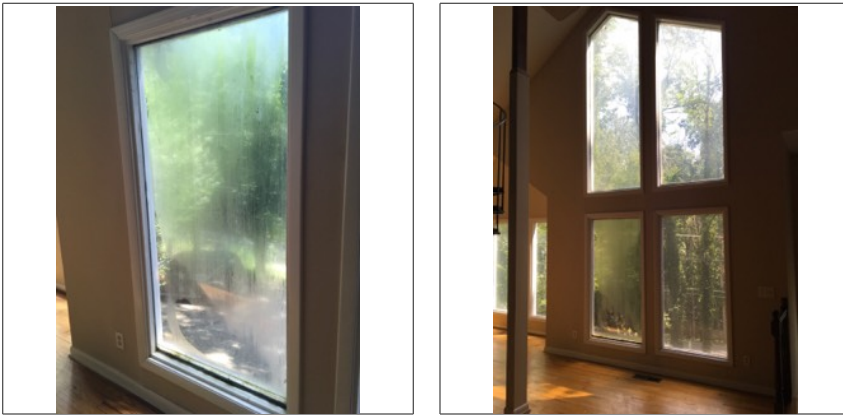
- Window sills/trim have some damage. Recommend repair and/or replacement by qualified contractor.
- Some screens are torn, damaged, or missing/not installed. Recommend repair and/or replacement.

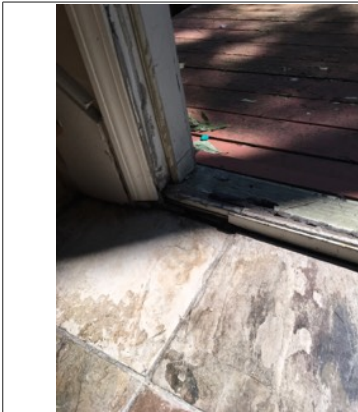
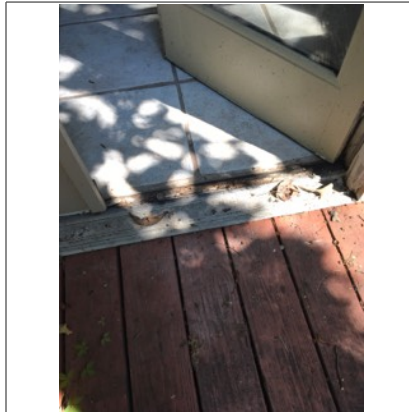
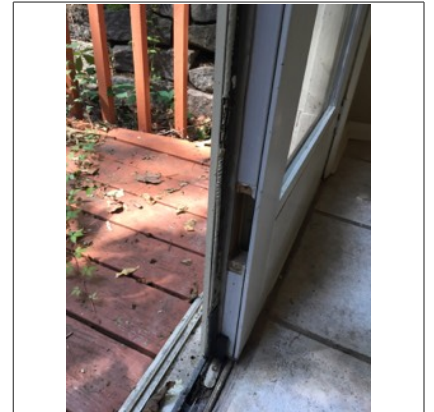
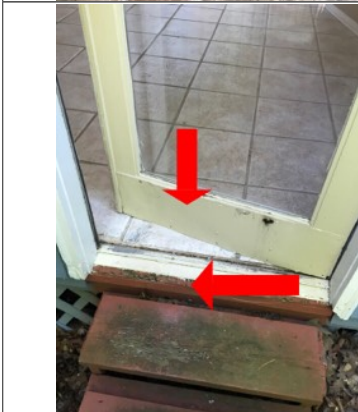
- Rear door and sill show signs of deterioration. Recommend repair and/or replacement by qualified contractor.
- Patio door has missing hardware, would not open at time of inspection. Recommend repair in near future.
- Patio door sill plate deteriorating. Potential for moisture penetration. Recommend evaluation and repair/replacement by qualified contractor.
- Front door sill plate damaged/deteriorating. Recommend repair and/or replacement by qualified contractor.
- Missing and/or damaged weather stripping on most exterior doors. Recommend replacement by qualified contractor.

Door and sill plate show major signs of deterioration

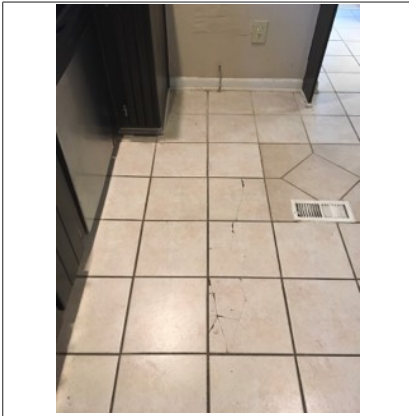
Comments •Kitchen tile floor cracked, but shows no signs of movement. Monitor and have evaluated and/or repaired by qualified contractor as needed.

Crack in tile

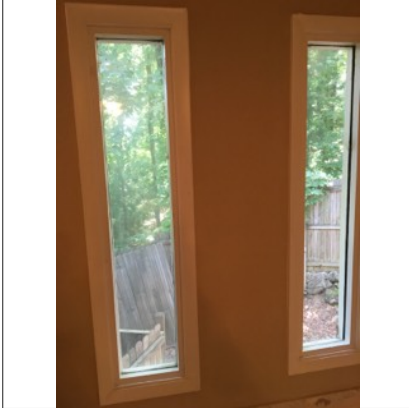
- Evidence of leaking insulated glass. Recommend repair/replacement of window
- Tub access panel sealed. Unable to inspect.
- Master Bath Tub faucet is loose. Recommend repair by qualified contractor.
- Sink stopper doesn't work. Recommend repair and/or replacement by qualified contractor.

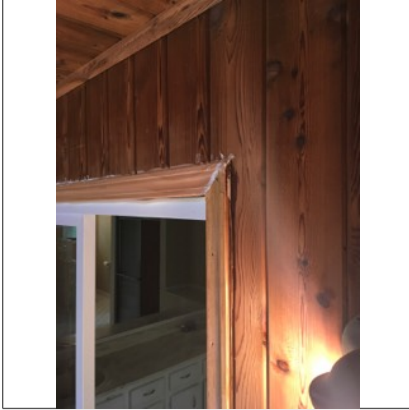
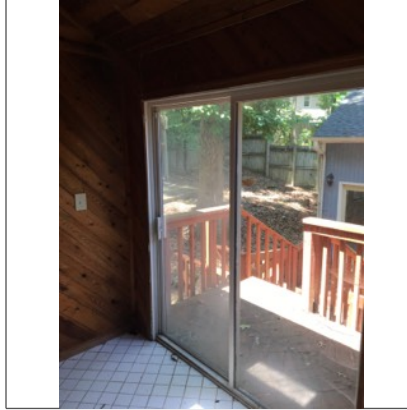
- Waterline not attached to tub. Recommend evaluation and repair by licensed plumber.
- Door trim not properly installed. Recommend evaluation and/or repair by qualified contractor.
- fogged glass

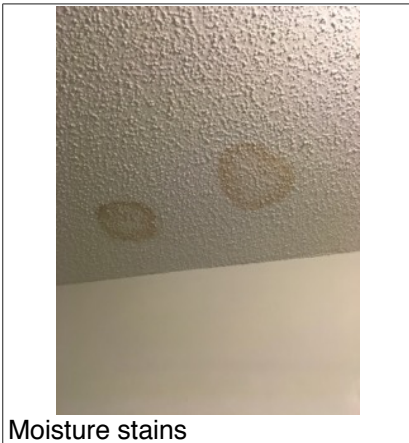
**Door(s)** ☒ Satisfactory  
**Walls & Ceiling** ☒ Satisfactory ☐ Holes/Damage  
**Moisture Stains** ☒ Yes Where: ☐ Ceiling Moisture Level: ☒ No Moisture Detected  
**Floor** ☒ Satisfactory  
**Window(s)** ☒ Marginal ☐ Evidence of Leaking Insulated Glass  
**Bedroom Egress Restrictd** ☒ N/A  
**Electrical** Switches: ☒ Yes ☒ Operable Receptacles: ☒ Yes Open Ground/Reverse Polarity: ☒ No  
**Ceiling Fan** ☒ None  
**Heat Source** ☒ Yes  
**Comments** •Evidence of leaking insulated glass. Recommend repair/replacement of window by qualified contractor.  
 •Moisture stains on closet ceiling, but no moisture detected.

Moisture stains

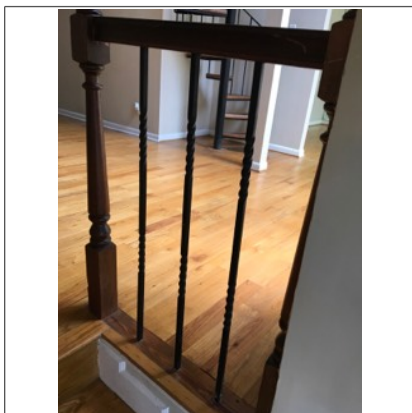
**Condition** ☒ Satisfactory  
**Handrail** ☒ Satisfactory  
**Risers/Treads** ☒ Satisfactory  
**Comments** •Entry way baluster spacing wider than typical, may pose safety hazard for small children, use with caution. Temporary measures may want to be employed until children are large enough or old enough to not be injured.

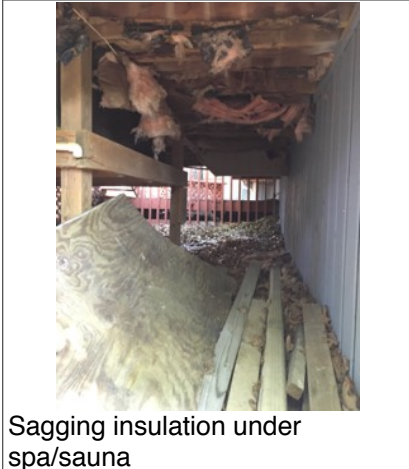
- Roof sheathing, examined from the attic, showed no major defects or moisture damage.
- Recommend extending bathroom vents to the exterior.
- Vapor barrier is installed improperly, recommend repair
- Insulation under flooring of dining room and spa/sauna is sagging and not installed properly. Potential for moisture being trapped. Recommend evaluation and/or repair by qualified contractor in near future.

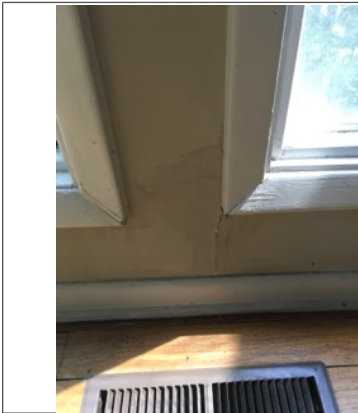
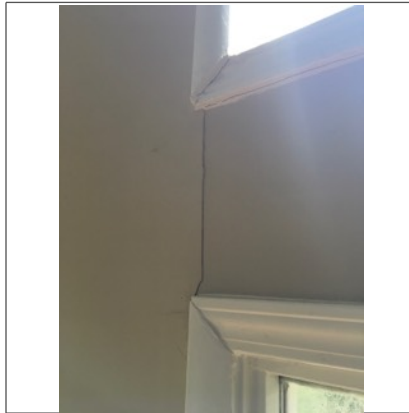
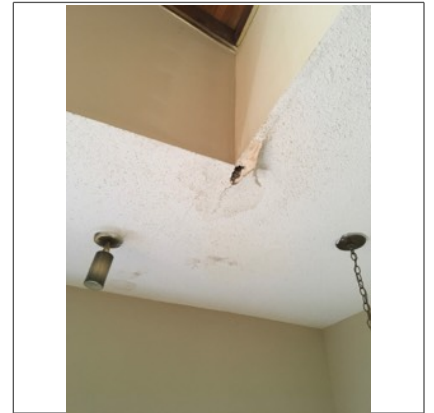
•Moisture staining around window framing and ceiling. Recommend evaluation and/or repair by qualified contractor.

**Comments** •Evidence of leaking insulated glass. Recommend repair/replacement of window

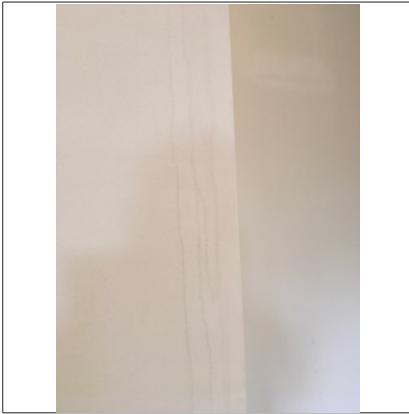
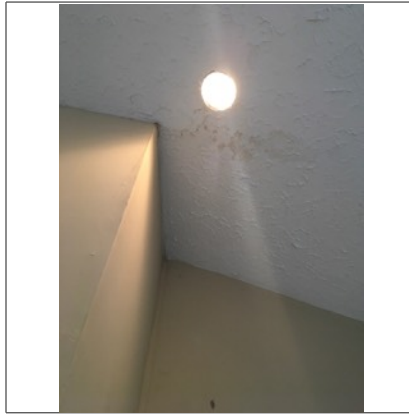
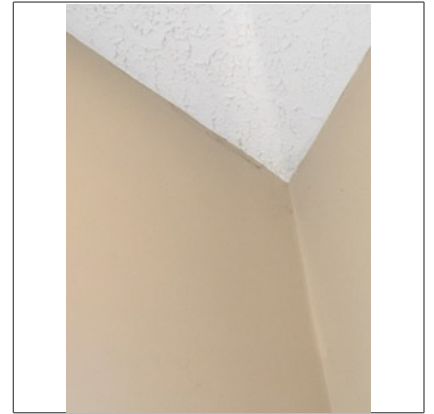
•Moisture staining on walls and ceiling. Recommend evaluation and/or repair by qualified contractor.

**Comments** •Tile floor is uneven. Recommend evaluation and/or repair by qualified contractor.  
•Patio door sill plates deteriorating. Recommend replacement by qualified contractor

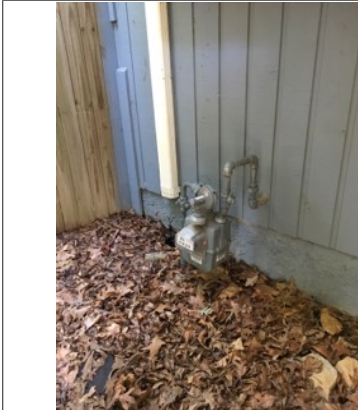
- Gas meter on exterior of home.
- Gas smell on exterior building by gas meter, gas detector verified leak. Potential SAFETY HAZARD. Recommend evaluation and/or repair by proper authorities or contractor.

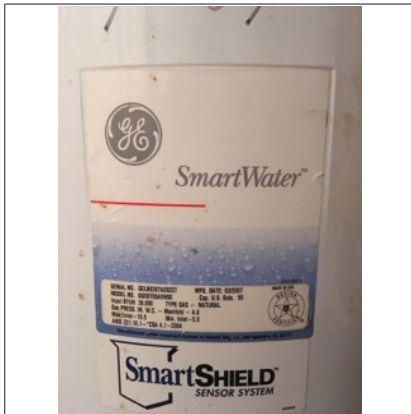
**Comments** •Water heater over 5+ years old. Budget for replacement with in the next 5-7 years.

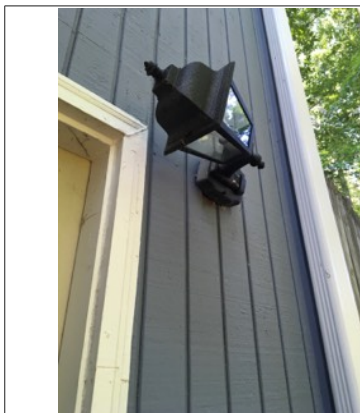
•Exterior lights not installed properly. Recommend repair by qualified contractor.

Not properly installed.

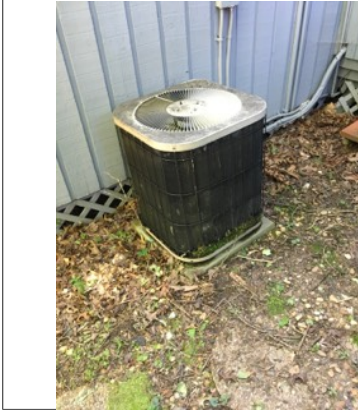
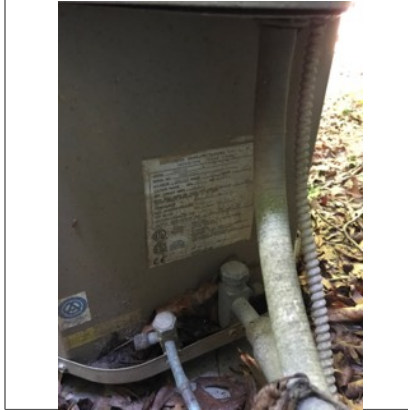
**Comments** •Heat pump nearing its life expectancy recommend budgeting for new unit in near future.  
•Have the air conditioners condenser coils cleaned as part of preventive maintenance.

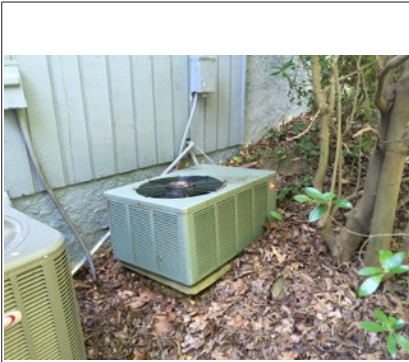
**Comments** •Recommend trimming back bushes and/or cleaning away organic debris from around the condenser unit as to maintain efficiency of unit.

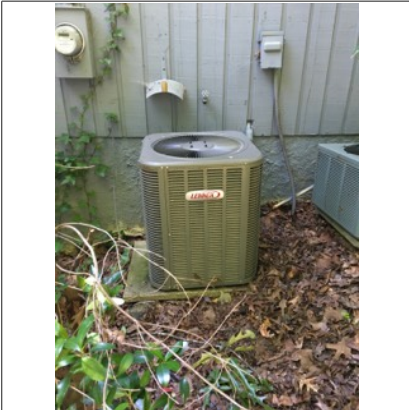
**Comments** •Recommend trimming back bushes and/or cleaning away organic debris from around the condenser unit as to maintain efficiency of unit.
